MAINTENANCE ALERT – ARMORWIRE CABLE GRIP ASSEMBLIES

APRIL 2020

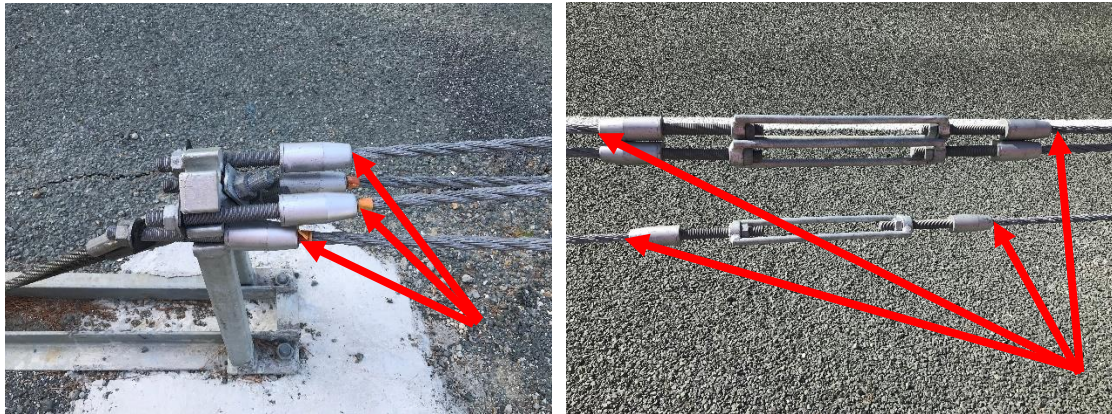
In addition to normal operational maintenance for the Armorwire system (as detailed [here](#)) the following additional maintenance requirement has been identified to address a corrosion issues identified in-service:

- Please inspect all cable grip assemblies at both the end terminal and turnbuckle locations for signs of internal corrosion at the point the wire enters the grip assembly as indicated above by the red arrows – ensure ALL grips are inspected
- IF NO CORROSION IS VISIBLE – please spray internally around the sides of the wire entry point, with CRC ANTI-RUST LUBRICANT (or similar)

- IF CORROSION IS VISIBLE ON THE WIRE ENTERING THE GRIP – please take a photo of the corrosion and note the location. Then contact CSP Pacific on the details below so we can arrange to send a new cable grip assembly to replace the one identified. The replacement grip assembly and any reasonable additional costs will be covered by CSP Pacific ONLY if pre-approved by email.
