Oclyte Tuff Coat™

Comparative accelerated corrosion test results

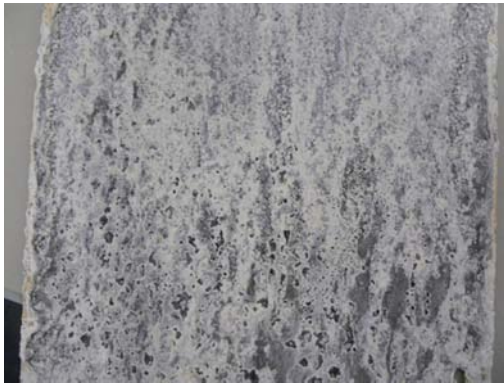
Hot Dip Galvanising after 1000 hours of salt spray testing

These tests simulated potential damage during installation and handling by scratching the coating on the test pieces down to bare metal. The coating was monitored over time at the scratched area and the undamaged area.

- Galvanising has sacrificed itself to protect the steel
- After 1000 hours of salt spray testing almost all the galvanising was gone
